Switchgear Malfunction Results in an Electrician's Death

Aug 1, 2004 12:00 PM, By John A. Palmer, Ph.D., P.E., Knott Laboratory, Inc.

Correct application of safety procedures is no substitute for properly functioning equipment

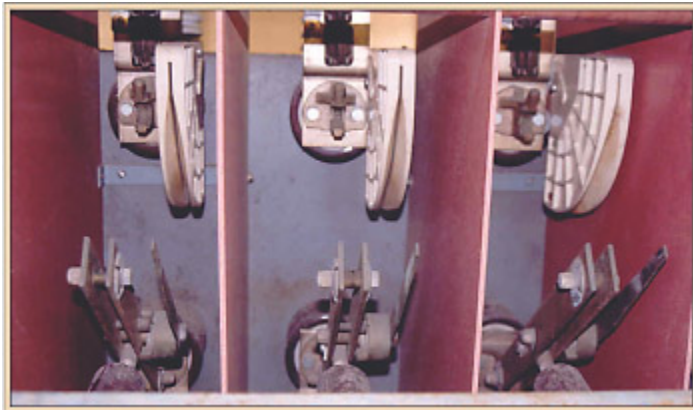
Photo 1. At least one of the flicker blades in this load circuit interrupter failed to operate.

The failure mode occurs in some circumstances that may vary with temperature, humidity, dust accumulation, and other factors when the frictional force between the arcing contact and arc chute exceeds the opening force of the interrupting contact spring and the opening force of the main spring. Thus, when the operator-applied force is stopped by the limit of travel in the handle, motion of the main switch blade is arrested, leaving the contacts in the position shown in Photo 5. At this point, the spring on the flicker blade isn’t sufficiently strong to break it free of the arc chute, leaving the arcing contact engaged and energized, despite the fully open position of the handle. So the device could be locked open even with one or more of the flicker blades still engaged, showing that the primary cause of the accident was a faulty design in the load circuit interrupter.

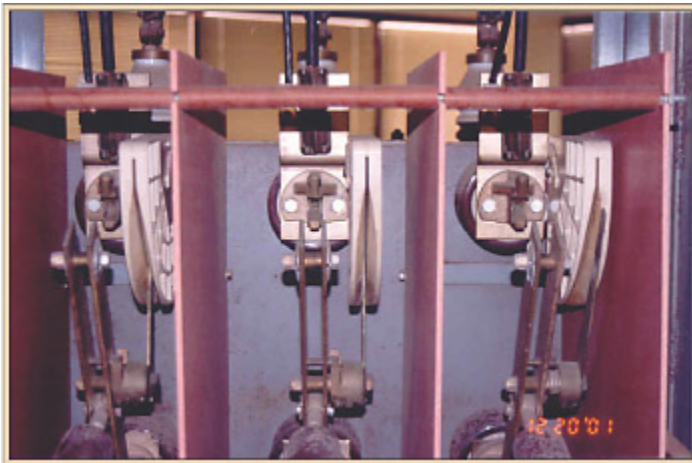
Photo 5. When a flicker blade stays in the arc chute, the corresponding phase remains energized.

Mode of failure. After the accident, inspectors found that the flicker blade of at least one of the poles was engaged in the arc chute, despite the fact the handle was in the open position and locked with a padlock. I observed a similar intermittent malfunction in two of the load circuit interrupters not associated with the accident that I tested. Sometimes, when the handle was moved from the closed position to the open position, one or more of the interrupting contacts were left in the arc chute although the main contacts were opened, as illustrated in **Photo 5** above.
